Structural Integrity Reserve Study
(Project #23-022)
for
Lakeridge Condominium Association, Inc.
1776 Sixth Street NW, #106
Winter Haven, FL 33881

Date: February 22, 2024

**Lakeridge Condominium
Structural Integrity Reserve Study**

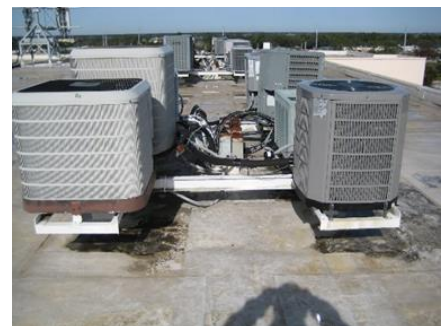
The building has a flat roof, and the size is approximately 18,214 square feet. Current inspections indicate the roofing system is a bitumen roof with silicone coating.

- We found very small areas, approximately 25 SF of very low wet moisture readings. They were in two areas, well below FBC allowable limits.
- You should recoat the roof with a thicker silicone roofing application. Sherwin Williams has a thicker system that is available for roofs that have heavy equipment on their roofs like your roof now has. The cost of that would be around \$125,000.00. There will be some small repairs and the cost of silicone has gone up. The silicone would have a 15-year thickness even though I would still suggest in 10 years recoating. I believe the thicker product will help greatly with the vibrations and thermal shock your roof is experiencing. Your roof will continue to get in a worst condition due to the issues I listed above. This is why I would suggest sooner is better than later.

- Code criteria: the Florida building code sets allowable minimum limits of moisture in the roof system as 5% in the roof membrane and 8% in the insulation (see chapter 15 section 1521.12)

This report recommends obtaining reserve funds to recoat the roof in 2027 and to obtain reserve funds to replace the roof in 2037.

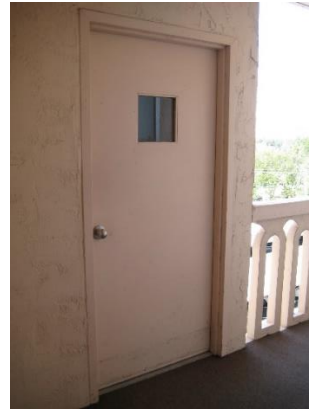
The building has approximately 110 exterior doors. All doors have metal frames. Some doors are composed of wood, some of metal, and some of glass with aluminum frames. Most doors are in very good condition. It appeared that some doors which are composed of wood and some doors which are exposed to direct weather show some degradation.

As such, this report recommends the Association obtain funds to repair and/or replace about ten doors (and possible frames) every 12 years.
