Structural Integrity Reserve Study
(Project #23-022)
for
Lakeridge Condominium Association, Inc.
1776 Sixth Street NW, #106
Winter Haven, FL 33881

Date: February 22, 2024

**Lakeridge Condominium
Structural Integrity Reserve Study**

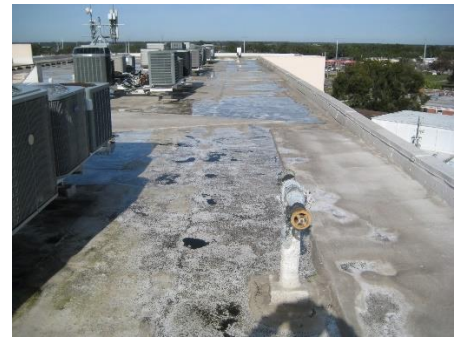
The building has a flat roof, and the size is approximately 18,214 square feet. Current inspections indicate the roofing system is a bitumen roof with silicone coating.

- We found very small areas, approximately 25 SF of very low wet moisture readings. They were in two areas, well below FBC allowable limits.
- You should recoat the roof with a thicker silicone roofing application. Sherwin Williams has a thicker system that is available for roofs that have heavy equipment on their roofs like your roof now has. The cost of that would be around \$125,000.00. There will be some small repairs and the cost of silicone has gone up. The silicone would have a 15-year thickness even though I would still suggest in 10 years recoating. I believe the thicker product will help greatly with the vibrations and thermal shock your roof is experiencing. Your roof will continue to get in a worst condition due to the issues I listed above. This is why I would suggest sooner is better than later.

- Code criteria: the Florida building code sets allowable minimum limits of moisture in the roof system as 5% in the roof membrane and 8% in the insulation (see chapter 15 section 1521.12)

This report recommends obtaining reserve funds to recoat the roof in 2027 and to obtain reserve funds to replace the roof in 2037.
