Structural Integrity Reserve Study
(Project #23-022)
for
Lakeridge Condominium Association, Inc.
1776 Sixth Street NW, #106
Winter Haven, FL 33881

Date: August 6, 2024

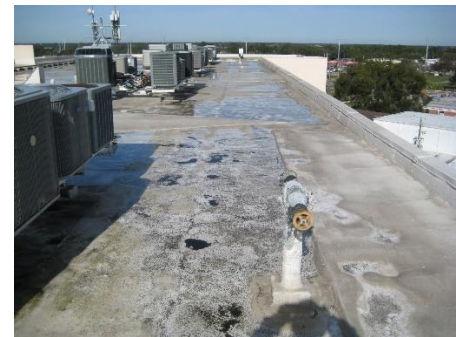
Roof:

The building has a flat roof, and the size is approximately 18,214 square feet. Current inspections indicate the roofing system is a bitumen roof with silicone coating.

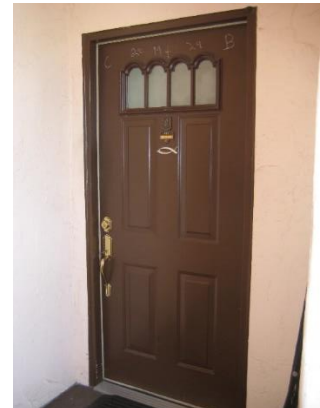
Doors:

The building has approximately 110 exterior doors. All doors have metal frames. Some doors are composed of wood, some are composed of metal, and some are composed of glass with aluminum frames. Most doors are in very good condition. It appeared that some doors which are composed of wood and some doors which are exposed to direct weather show some degradation.
